POST DISASTER WASTE MANAGEMENT DURING THE 2014 SRINAGAR FLOOD

GN Qasba, Rohit Magotra, Sonika Rajput and Ananya Bhatia

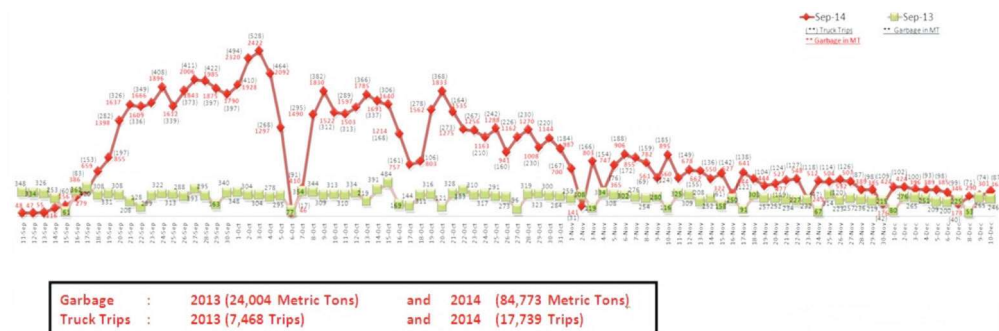
Figure 21 Garbage collected and Truck trips
Source: SMC, 2014

Garbage	: 2013 (24,004 Metric Tons)	and 2014 (84,773 Metric Tons)
Truck Trips	: 2013 (7,468 Trips)	and 2014 (17,739 Trips)

As cleaning and sanitisation progressed, SMC team worked round-the-clock without any pause and in a short span of time, getting the city life back to normalcy, an effort that was highly appreciated by the public. Figure 21 shows the graph of Garbage collected and daily truck trips to the landfill site. Table 2 enlists the achievements of SMC during sanitation drive.
